# Micromechanisms of Dynamic Crack Propagation in an AISI 4340 Steel

R. GODSE\*, G. RAVICHANDRAN† and R. J. CLIFTON

Division of Engineering, Brown University, Providence, RI 02912 (U.S.A.)

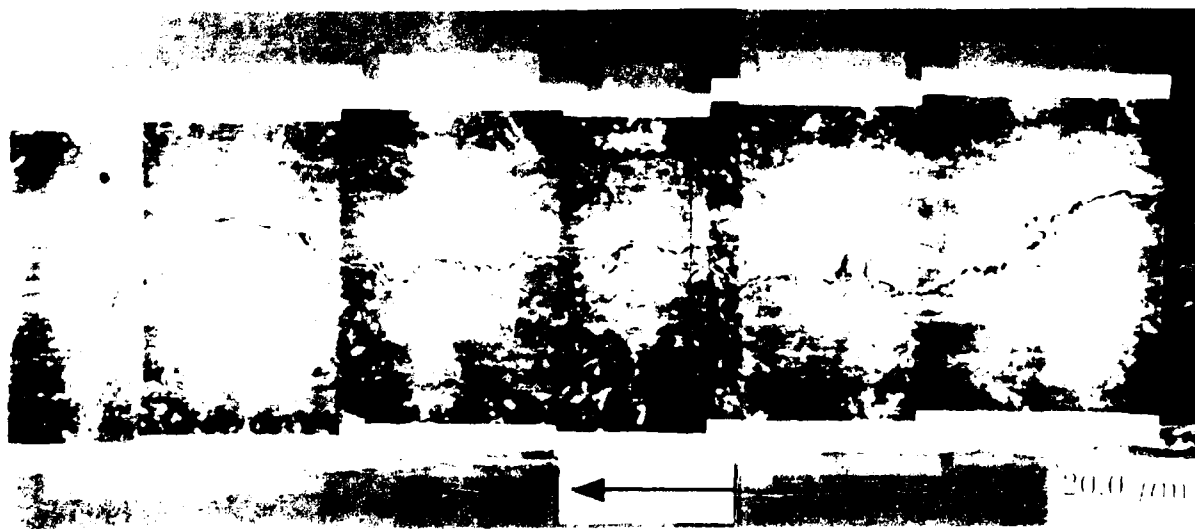
Fig. 5. Nature of the crack tip region for the room temperature experiments (shot 82-01).

From the crack profile studies, it was found that the fracture path and the prior-austenite grain boundaries were unrelated. Crack propagation was thus transgranular with respect to the prior austenite grains. Figures 4 and 5 show the nature of the crack tip region for low temperature and room temperature experiments respectively. The total extent of the dynamic crack growth is at least three times that shown in the figures; hence the fatigue crack tip is far from the regions shown. In both cases, the crack is discontinuous near the tip and is composed of cracked segments several grain diameters long, separated by unbroken ligaments. Another important feature is the presence of small cracks with dimensions smaller than the

average grain diameter (Fig. 6). Over 95% of the detected microcracks were inside bainite packets. These microcracks are either isolated from the main crack (Fig. 6(a)) or misoriented with respect to the fracture path. Figure 6(b) shows microcracks in a low temperature specimen etched to reveal prior-austenite grain boundaries, and Fig. 6(c) shows microcracks in bainite packets in a room temperature specimen. The arrows in Figs. 4-6 indicate the direction of crack propagation.
